**“BUT I’VE ALWAYS DONE IT THIS WAY.”**

**TECHNICAL SUPPORT - IT MAKES A DIFFERENCE.**

**Stewart Grice, Metallurgical Manager,  
Cookson Precious Metals Ltd.,  
Birmingham, England.**

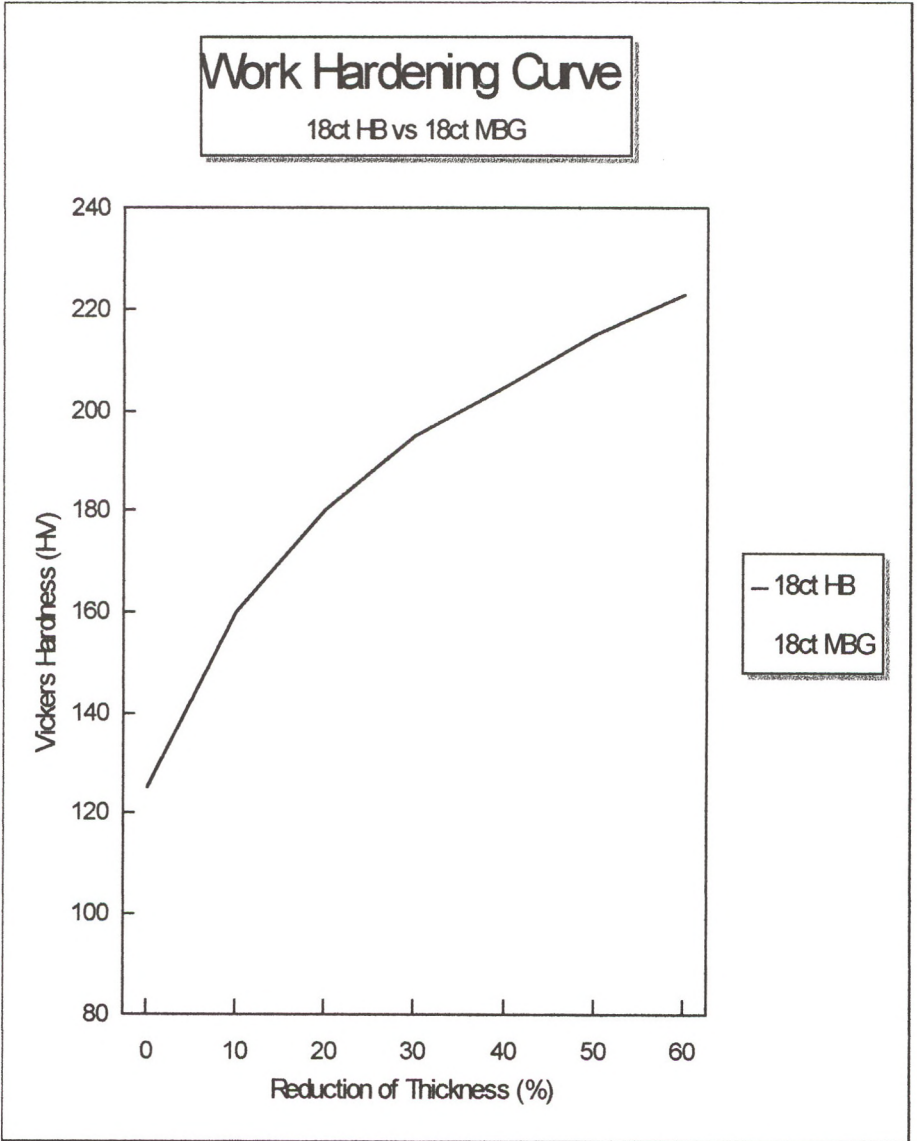
Figure 1. Work hardening curves of 18ct HB vs 18ct MBG.

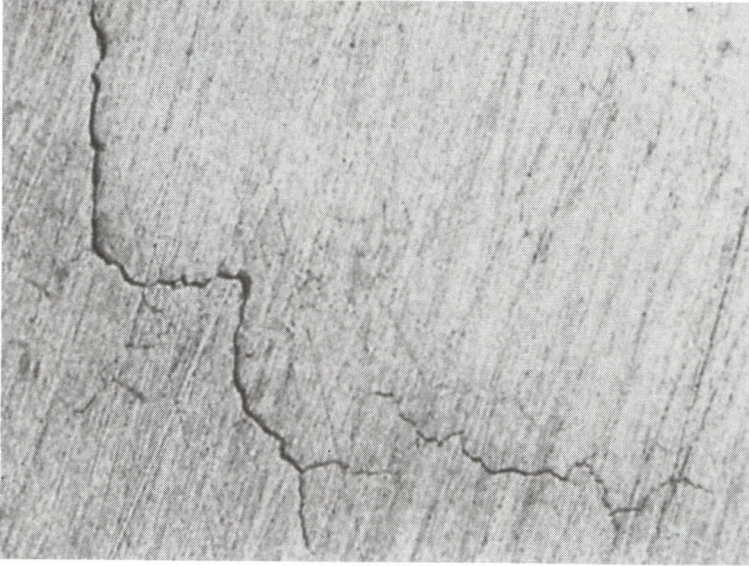
Figure 2. Surface of failed 18ct MBG workpiece. Mag x 30.

much higher. Microscopic particles of lead picked up on the surface of the workpiece were sufficient to result in subsequent processing difficulties. Post contamination heat treatment operations - soldering, annealing or hardening for example - have resulted in lead diffusion via the grain boundaries. Prior surface cracking was not necessary for this to occur, alloying readily taking place resulting in a rapid decrease in strength and ductility in the affected areas. Further examination of the workpiece under a high magnification stereo microscope confirmed the presence of lead debris at the surface and diffusion into the surface.

The customer was immediately made aware of our findings and the failure mechanism explained with the aid of micrographs and the relevant analysis traces. The customer confirmed that this and other jobs had been manufactured using lead formers during the raising operation. Some craftsmen used tissue paper as an interleave between the former and the workpiece however this tore easily and was not always used. All workpieces were cleaned prior to any heat treatment operation in order to remove any lead debris remaining after the forming process. Any damage to the formers will potentially deposit debris on the workpiece - often not visible to the naked eye. This residual debris was the origin of the contamination identified. Subsequent annealing has led to diffusion through the grain boundaries resulting in the brittle grain boundary phase. Minimal cold work was required to result in failure. Although the customer insisted the workpiece was cleaned prior to annealing this was not to an acceptable level. It was suggested that a more resilient interleave was used to minimise any surface contamination since the customer intended to continue using lead formers. It is believed a more resilient grade of paper is used and particular attention paid to cleaning workpieces prior to any heat treatment operation. To date there has not been a reported recurrence of this problem - once the failure mechanism had been identified and explained to the customer appropriate action was taken to prevent this. Without the technical analysis further expensive failures may have occurred.

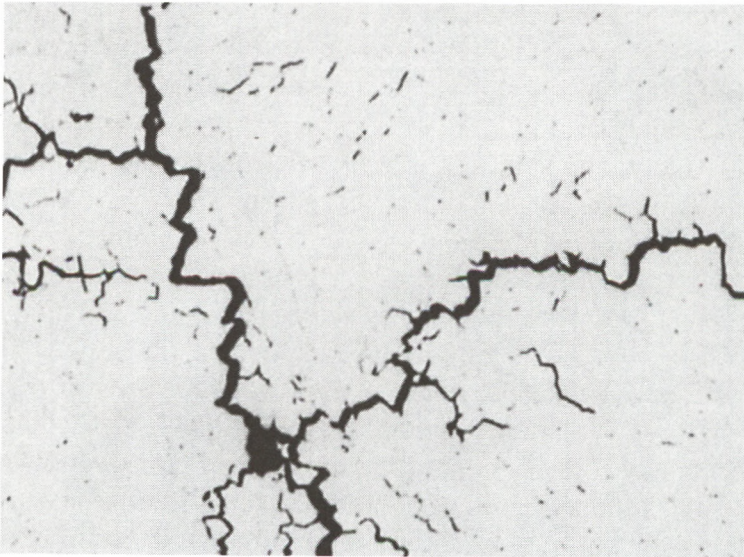
Figure 3. Inter-granular cracking in 18ct MBG. Mag x 80

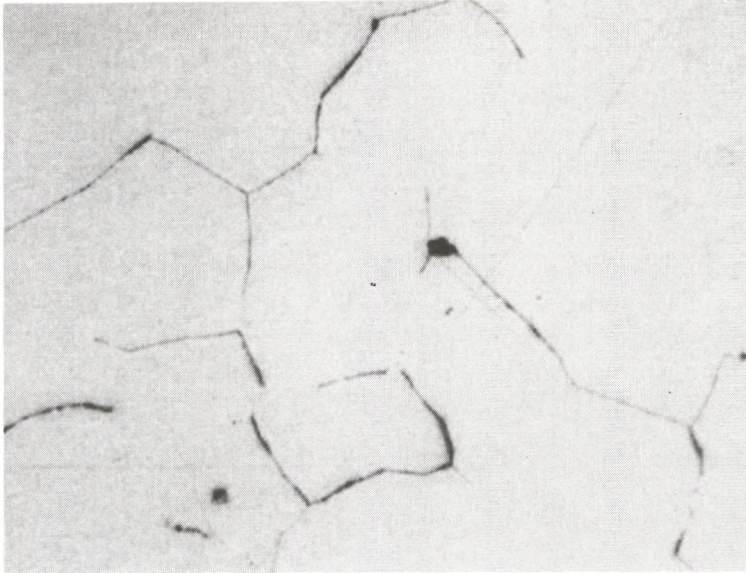
Figure 4. Grain boundary impurity in 18ct MBG. Mag x 800.

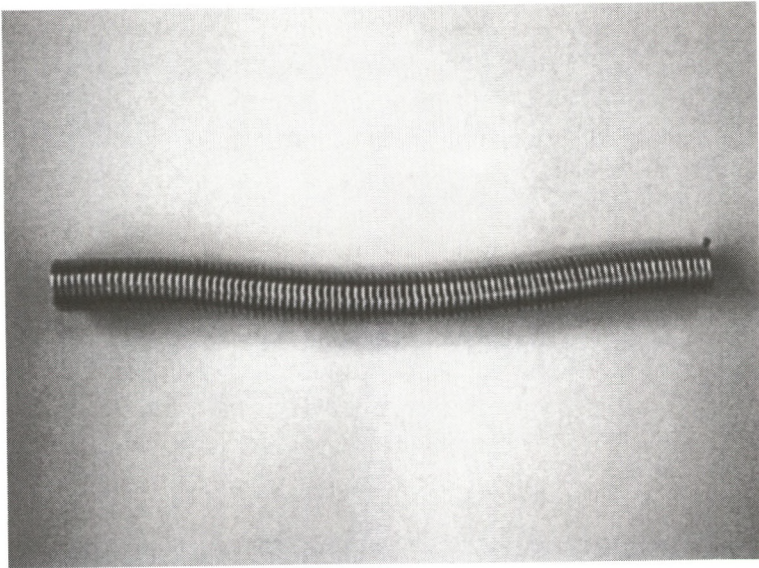
Figure 5. Hoop earring coil.

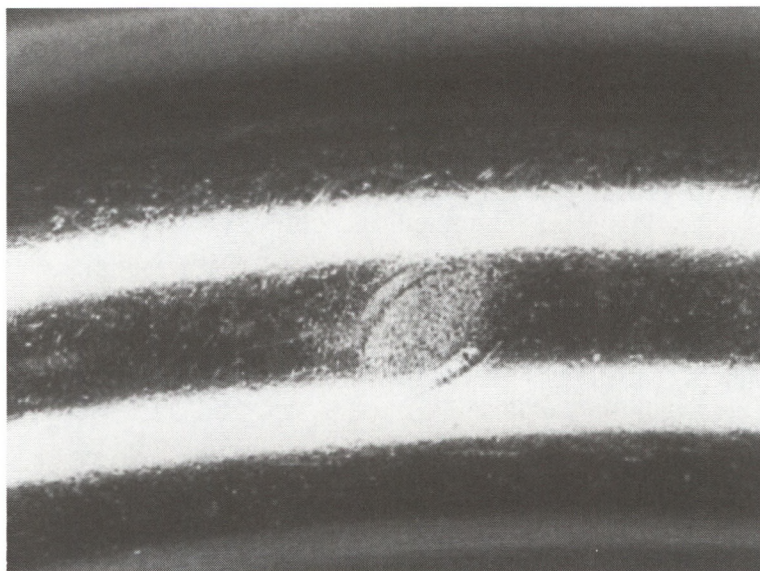
The problem brought to the attention of Technical Services was surface related. After finishing random "blemishes" were evident on the surface of the earrings (figure 6). Additional finishing of the bulk product was unsuccessful in removing the blemishes resulting in large quantities of scrap product. This did not appear to be particular to any size or style of earring and was, according to the operators, increasing in frequency. The customer was certain this was a problem associated with the strip - possibly rolling defects. Strip held in stock for this customer was inspected; no external defects or inclusions were identified and the strip appeared to conform to all order requirements. Examination of returned

Figure 6. Surface blemish on 9ct hoop earring. Mag x 30.

These findings were explained to the customer and possible solutions discussed. It was agreed that the most practical option was to purge the furnace every morning prior to processing with a scoured copper block and to regularly - ideally once a week - brush the furnace interior to remove any build up of debris. Again, since the suggested actions were implemented there has been no reoccurrence of this

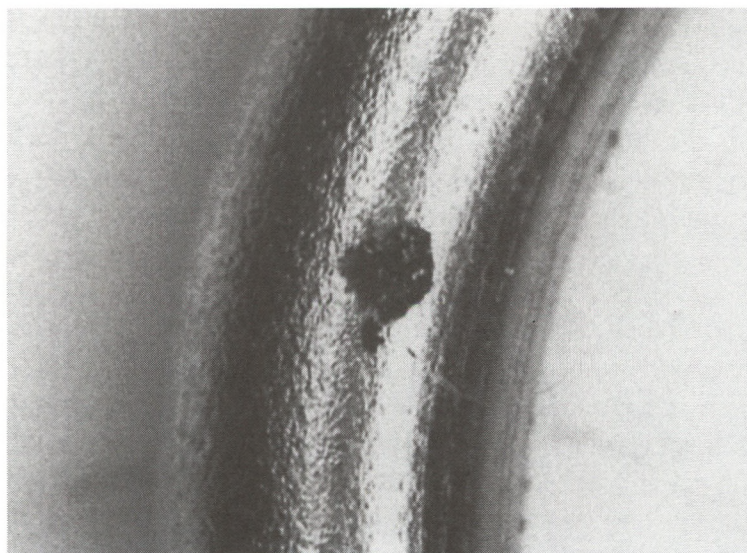
Figure 7. Surface inclusion on 9ct hoop earring. Mag x 20.

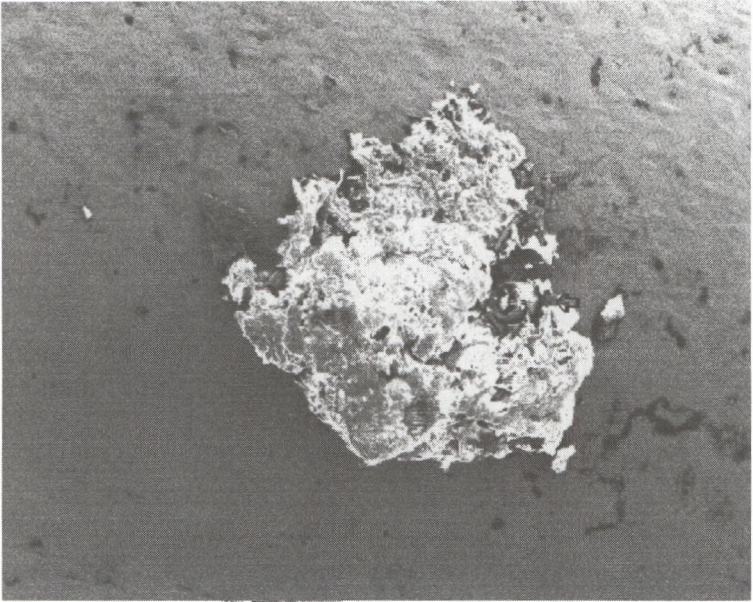
Figure 8. Surface inclusion showing swarf. Mag x 95.

When deposits reach a certain level they become detached from the furnace tube and fall onto the earrings. Furnaces that are used to heat treat zinc containing alloys require regular cleaning - usually by brushing - in order to remove any deposits that have built up on the inside of the furnace. A further precaution is to ensure the furnace is purged by passing a copper bar through - ideally each morning before any product is processed. This will scavenge any zinc in the furnace - zinc will readily react with the copper block. This block needs to be scoured prior to use to ensure "virgin" copper is presented to the furnace interior. It is difficult to prevent the zinc volatilisation in practice; zinc has a high vapour pressure and as such furnace conditions required will be difficult to obtain. Considering there is a moving belt and workpieces in the furnace together with a moving gas atmosphere and convection effects there is little practical chance of preventing zinc deposits on the furnace tube interior. It has been suggested that possibly a protective coating - such as Argotect (5) - may be utilised to prevent surface exposure and therefore any volatilisation however since this will require removal after the operation it is not a practical option when the quantities of earrings being produced is considered. Regular cleaning of the inside of the furnace by brushing will be sufficient to prevent further build up of other debris.

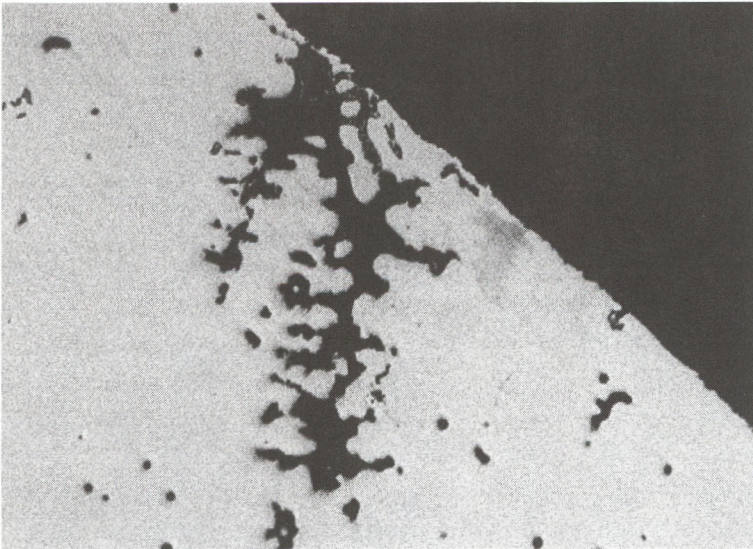
Figure 10. Shrinkage porosity in a 9ct red casting. Mag x 320.

- Excessive shrinkage porosity throughout the casting section (figure 10). Examination of the spruing system suggested this was adequate for progressive solidification to occur.
- Excessive levels of copper oxide present throughout the section

The above defects are indicative of overheating the melt prior to casting. There was a heavy oxide layer generated on the surface of the castings as a result of the high copper content of the alloy and a high casting temperature. Prolonged acid pickling was required to remove the layer resulting in a copper depleted surface, the pale yellow colour being characteristic the gold, silver and zinc rich surface remaining. When subjected to a vigorous polishing operation the original colour returned.

The customer was informed of the findings and the reasons discussed. It was accepted that the grain conformed to order requirements and the casting process required optimisation for this alloy. The customer agreed to change his casting parameters in order to prevent the formation of a heavy oxide layer. There was the suggestion that the calibration of the optical pyrometer be checked since the stated 100°C superheat would not normally result in the defects identified. The presence of the chlorine reaction is unusual. It appears to be coincidental with surface porosity suggesting chlorine has been introduced in liquid form and entrapped. The customer insisted that all casting trees are pickled in hydrofluoric

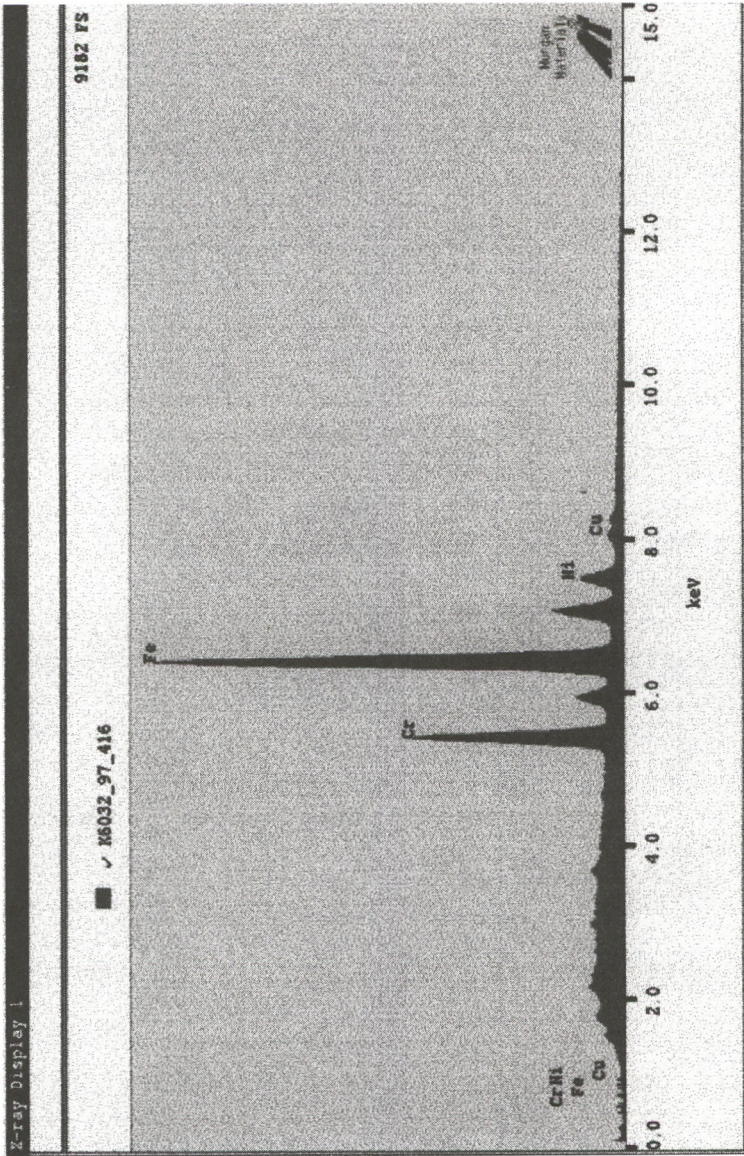
Fig. 9

- Zinc has volatilised from previously stress relieved earrings and has condensed on the inside of the furnace tube.
- Iron has originated from the furnace tube. Further examination of discrete surface inclusions revealed the presence of nickel and chrome confirming a nichrome type steel - a family of alloys used for furnace tubes (figure 9).

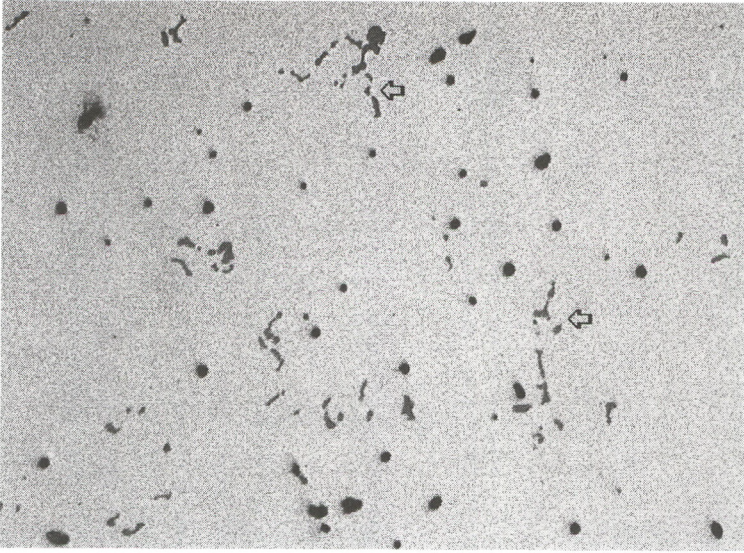
Figure 11. Copper oxide in a 9ct red casting. Mag x 320.

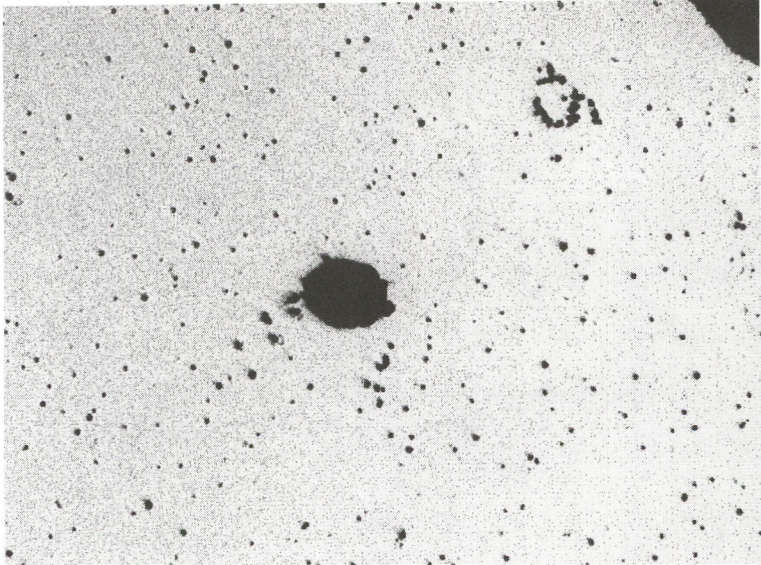
- The presence of several large spherical gas pores (figure 12). Closer examination at higher magnifications revealed the presence of gas microporosity throughout the section.
- Analysis at higher magnification revealed the presence of a copper depleted layer at the surface. Etching the microsections with alcoholic ferric chloride confirmed this (figure 13).
- Analysis of the casting surface by X-ray fluorescence confirmed a reduced copper content.
- The presence of a chlorine reaction at the surface of the castings (figure 14). This was identified by microprobe analysis on the electron microscope.

Figure 12. Gas porosity in a 9ct red casting. Mag x 160.

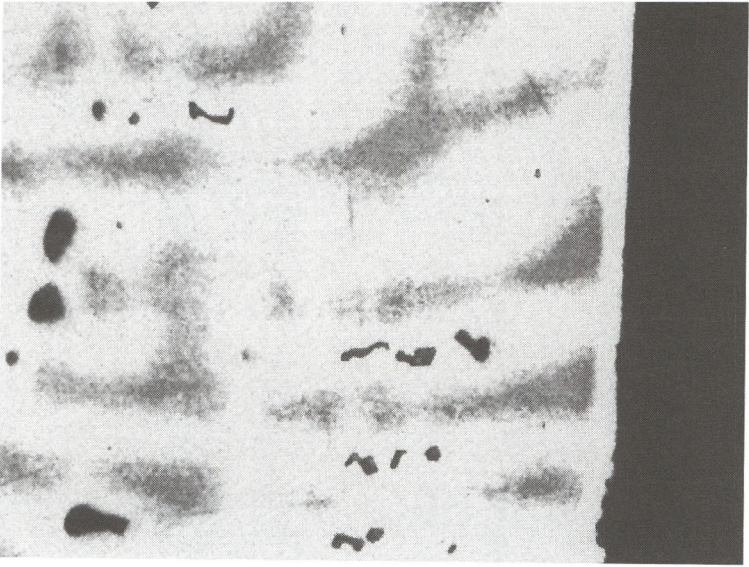
Figure 13. Highlighted surface layer in 9ct a red casting. Mag x 1280.

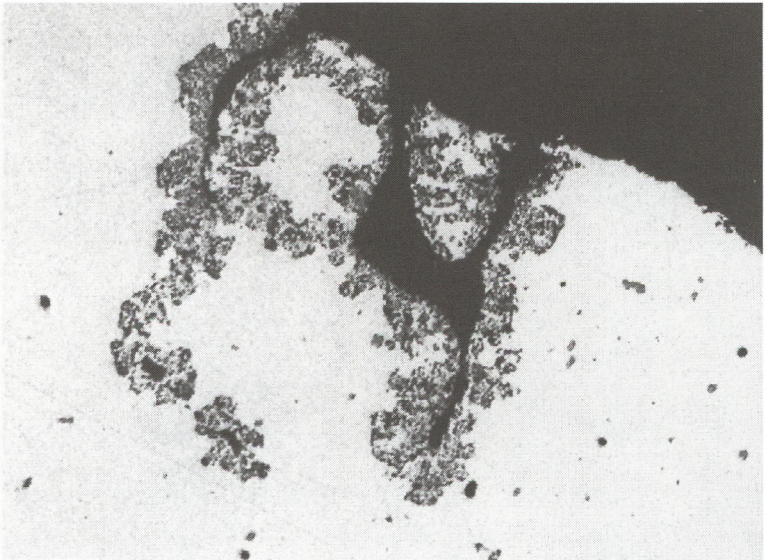
Figure 14. Chlorine reaction in a 9ct red casting. Mag x 320.

acid and at no time come into contact with hydrochloric acid. The reaction was identified prior to etching the microsection in alcoholic ferric chloride in the laboratory negating any possibility of cross contamination from this source. It can only be assumed that the casting has been immersed in a chlorine containing liquid at some stage during processing. This is not immediately detrimental however will result in corrosion products discolouring the surface of the castings. There is also the possibility that these relatively high concentrations of chlorine may lead to stress corrosion failure. New grain was supplied and after minimal trialing successful castings were produced.

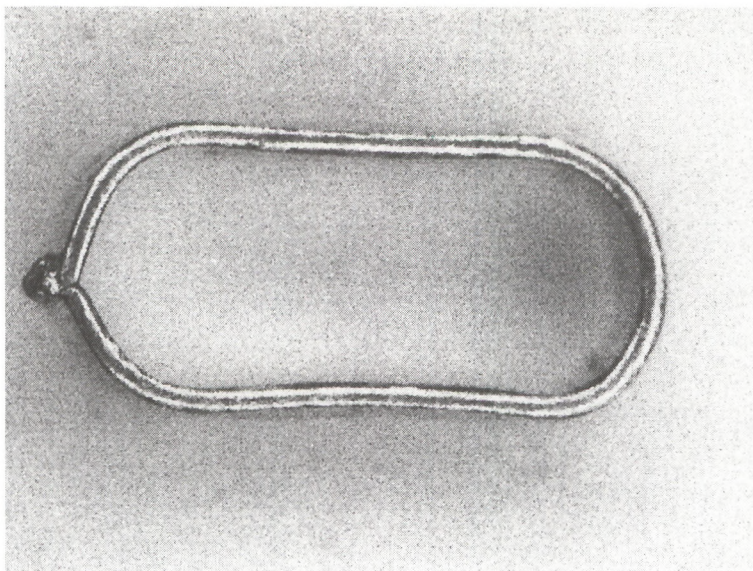
Figure 15. Solder “balling” on a 14ct link - plan view. Mag x 30.

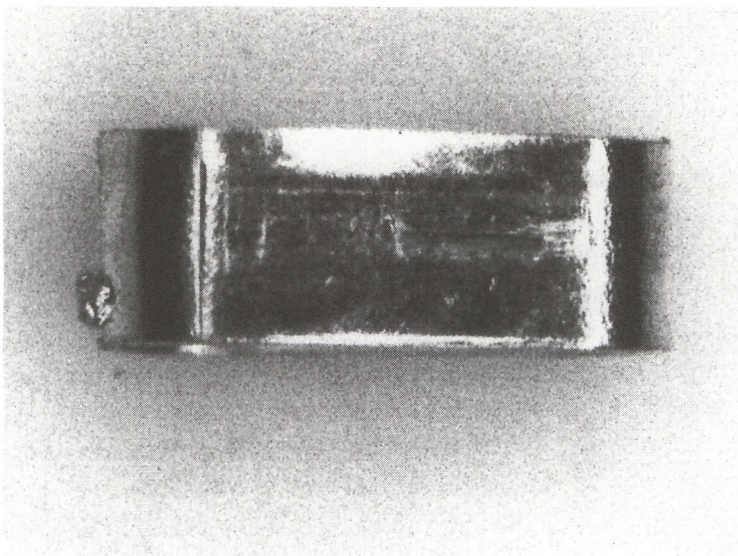
Figure 16. Solder “balling” on a 14ct link - side view. Mag x 28.

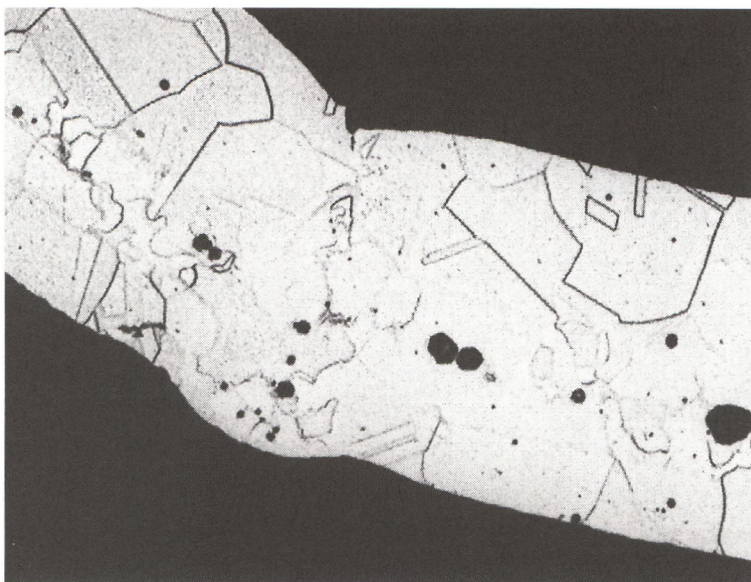
Figure 17. Excess solder fillet in a 14ct link. Mag x 320.

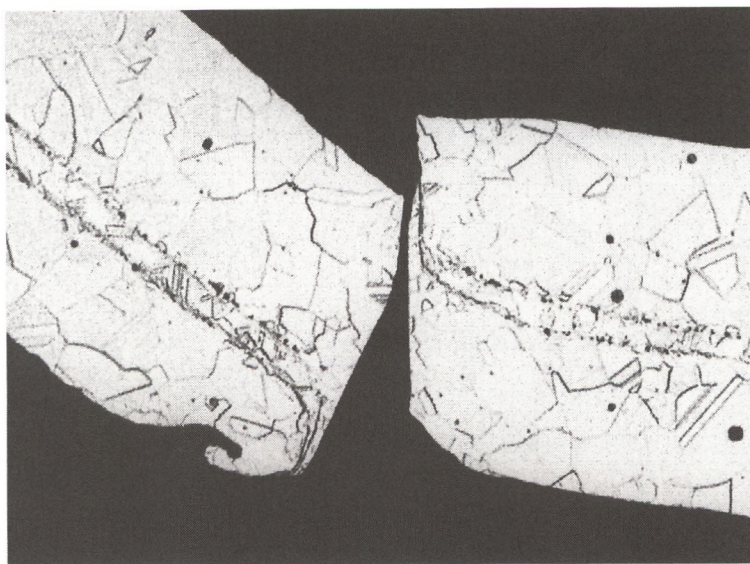
- Unsuitable joint geometry (figure 18). The ideal joint geometry for links manufactured from solder filled wire is parallel faces. If equipment, wire or design limitations will not allow this then any resultant “V” must be open towards the inside of the link. In this case the joint faces were neither parallel nor the resultant “V” facing the inside of the link. The geometry had discouraged even solder flow through the joint and lead to the formation of a large solder fillet. The resultant link was weakened due to the relatively brittle nature of this excess solder present in the joint area. It was unlikely this geometry was the result of the wire properties - there was no evidence of springback occurring. It was probable that the chain machine required re-setting.

- The joint faces were smeared (figure 18). This resulted in poor solder flow - the solder core exits clearly evident on the link faces and not on the joint faces. Balling of the solder core had resulted with poor flow into the joint area. This was either the result of the wire being too soft or the cutter being blunt. Testing had confirmed the tape conformed to hardness requirements therefore

Figure 18. Poor joint geometry and smearing in a 14ct link. Mag x 320.

the cutter required inspection and re-sharpening if necessary.

The customer was immediately informed of our findings. Inspection of the machine confirmed the cutter was blunt. This was sharpened to produce a satisfactory cut; further fine tuning produced satisfactory joint geometry. An inspection and maintenance routine was put in place to prevent reoccurrence. The customer agreed although they would eventually have arrived at the same conclusions, it would have taken far longer and wasted more expensive production time and scrapped product. The involvement of Technical Services was key to a quick and acceptable outcome.

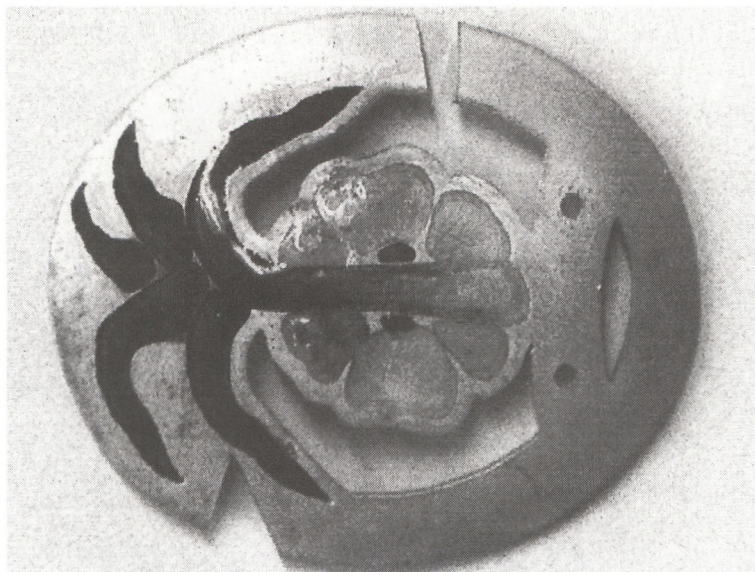
Figure 19. Standard silver badge of office. Mag x 1.2.

Initial examination of the workpiece confirmed the presence of a black “contamination” on top and bottom surfaces resulting in metal discolouration (figures 19&20). Areas of enamelling were discoloured and flaking with poor adhesion. Microsections of the contaminated and non-contaminated areas revealed the following:

- Any heat treatment must be performed in a shaded area if a torch is used. Metal colour can then be accurately judged and the possibility of overheating minimised. It is not uncommon to overheat alloys - particularly silver - on sunny days if adequate shading is not used.
- Workpieces should be pickled in nitric acid prior to enamelling. All acid residues must be removed after this process - the use of an alkali neutralising solution is recommended and preferably the use of an ultrasonic bath. All entrapped acids will eventually result in corrosion products.

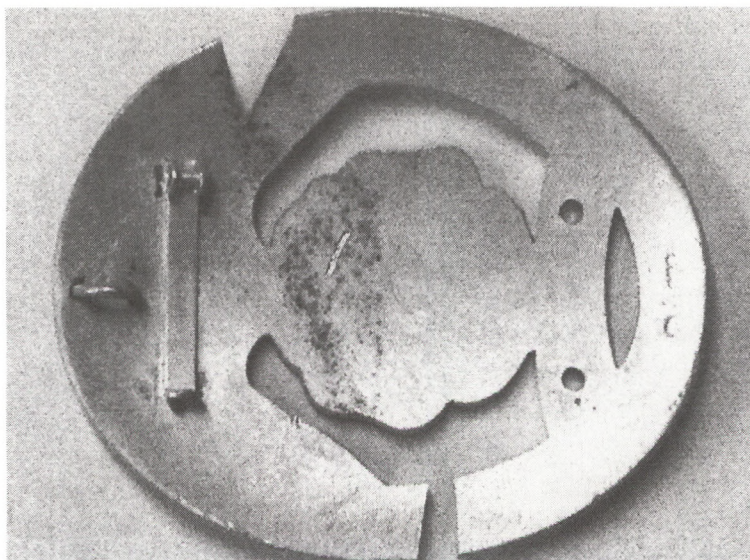
Figure 20. Discoloured rear surface. Mag x 1.2.

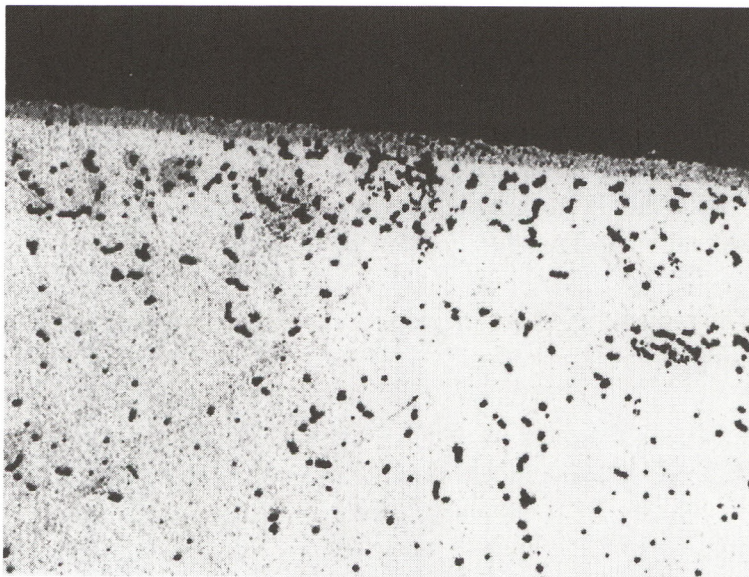
- Partial liquation of the workpiece. Through section porosity typical of incipient fusion was present (figure 21).
- The presence of oxide extending into the workpiece via surface porosity suggesting liquation had occurred prior to or during the oxidation process.
- Areas not discoloured had little or no surface porosity (figure 22).

The workpiece had been heated above the solidus of standard silver resulting in grain boundary liquation. Pickling acids used in the enamelling process had become entrapped in surface porosity and resulted in corrosion products discolouring the surface. These will be hastened - and blackened - by the subsequent heating operation when

Figure 21. Surface porosity in “discoloured” area. Mag x 80.

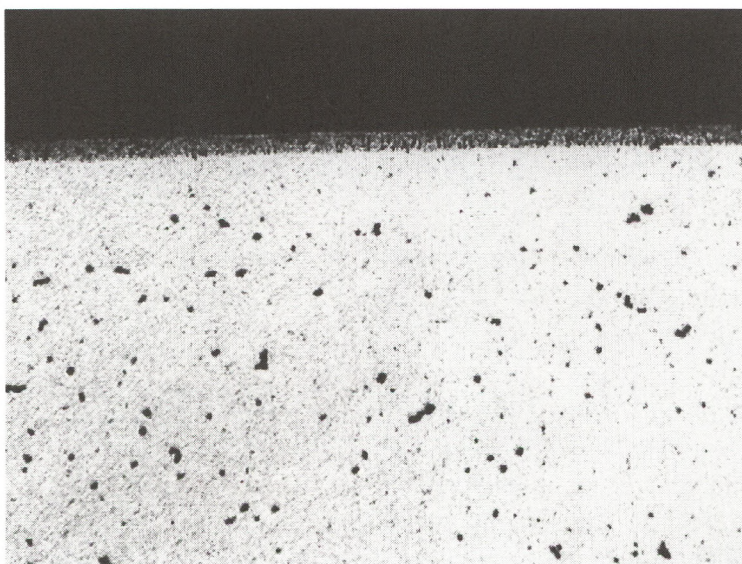
Figure 22. Surface free of porosity in “clean” area. Mag x 80.
