**UTILIZATION OF LASERS
IN THE JOINING OF GOLD AND PLATINUM
FOR JEWELRY**

**Costantino Volpe, Tiffany & Co.
and
Richard D. Lanam, Engelhard-CLAL LP**

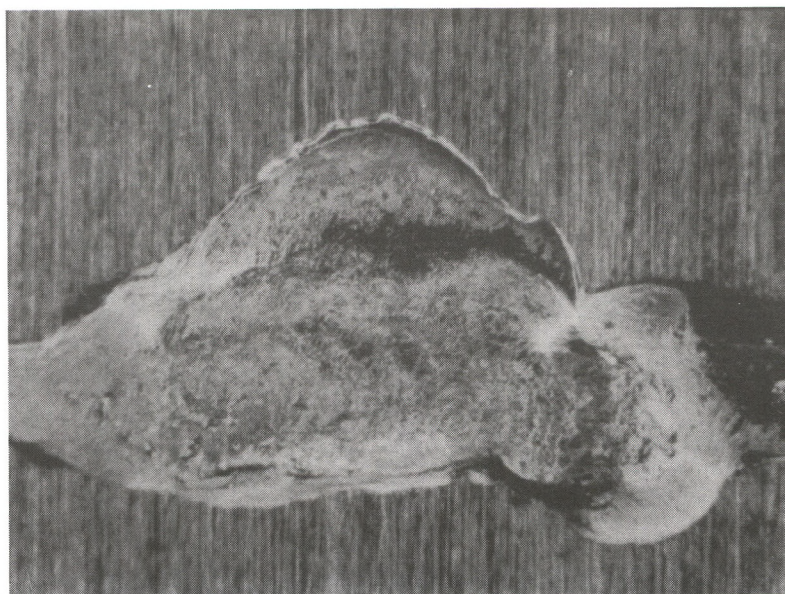
Figure 5. Photograph of the brazed bevel joint of the 0.030 inch thick, Pt-4.8Ru alloy at 15x.

Photographs of a typical laser weld and braze of the Pt-4.8Ru alloy are shown in Figures 4 and 5, respectively. The laser weld is typified by a raised bead and a shiny appearance. The braze is flush with the surface of the parent material but has a very dull, oxidized appearance.

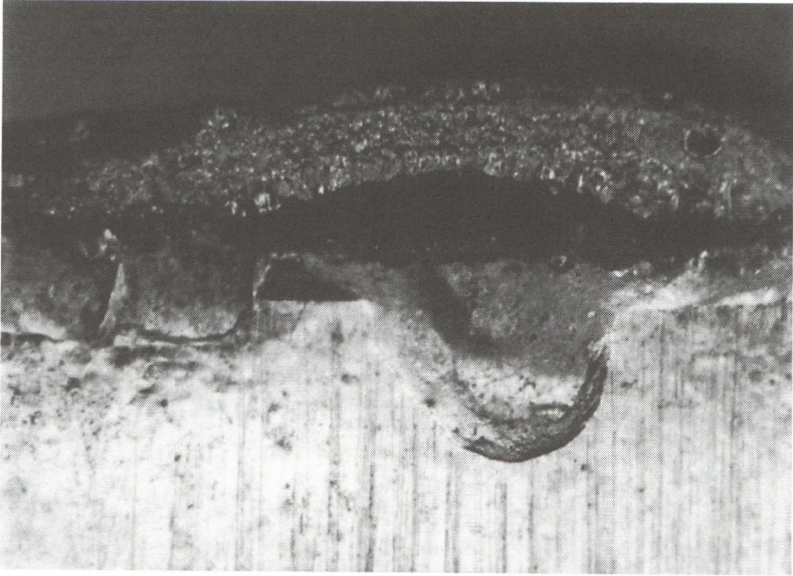
Figure 9. Photograph of the 1T bend of the brazed bevel joint of the 0.030 inch thick, Pt-4.8Ru strip at 15x.

The photograph of the failed bend sample from the brazed bevel joint is displayed in Figure 9. The joint completely separated. Closer examination of the fracture surface is seen in the scanning-electron-micrograph of Figure 10. Large voids are present in the fracture. Likewise, the fractured bend sample and the scanning-electron-micrograph of the brazed butt joint are shown in Figures 11 and 12. Areas of porosity and poor wetting are seen. Photomicrographs of the weld cross-sections for the two types of joints are displayed in Figures 13 and 14. The first feature that stands out is the much larger grains of the strip next to the brazed bevel joint compared to the laser weld and then the even larger grains of the butt joint. The bevel character of the bevel is clearly evident along with the porosity present at the interface with the filler metal. The lack of wetting of the interface is seen with the butt joint. The photograph of the failed bend sample, the scanning-electron-micrograph of the fracture and the photomicrograph of the braze cross-section for the 1700 solder are seen in Figures 15 through 18. The difference between the braze joints with the 1700 solder and the Pt-5Au filler metal is, there is less grain growth in the strip due to the lower melting point, conversely, there is less alloying and wetting.

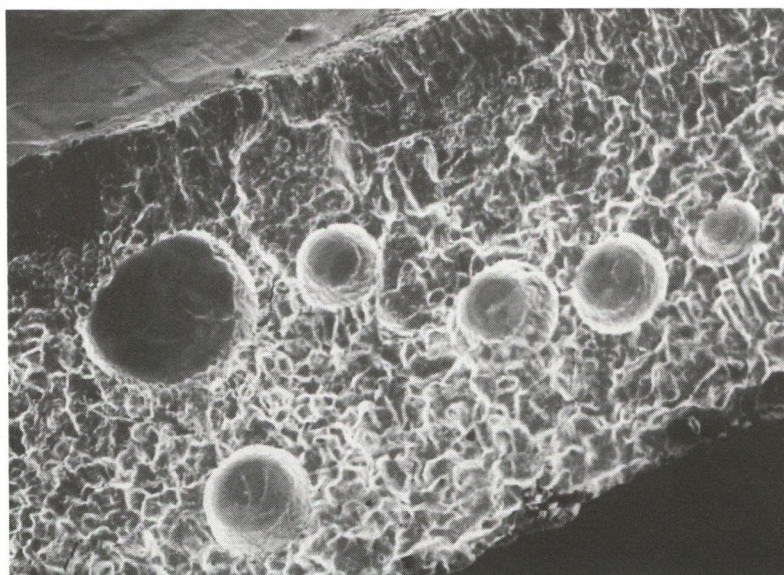
Figure 16. Scanning-electron-micrograph shows the fracture surface of the 1T bends from the brazed butt joint using 1700 Pt solder on the 0.030 inch thick, Pt-4.8Ru alloy strip at 100x.

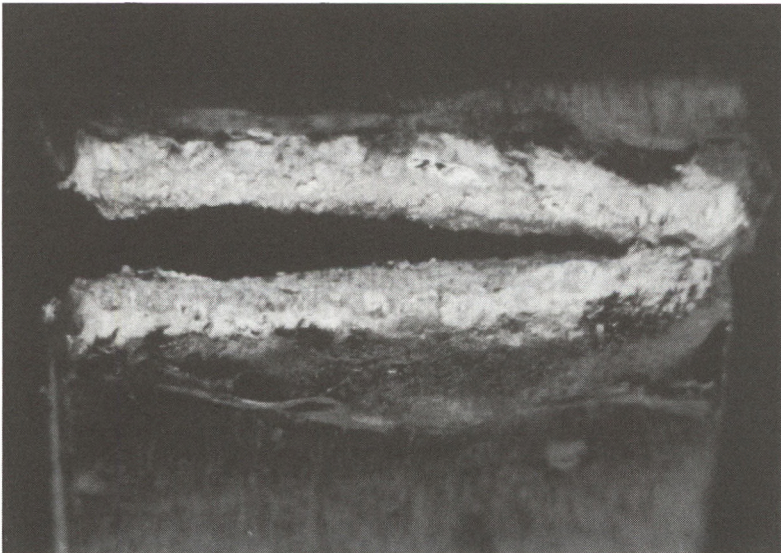
Figure 24. Photograph of the 1T bend of the brazed butt joint of the 0.030 inch thick, Pt-4.8Ru alloy casting at 10x.

The examination of the fracture surfaces of the brazed joints of the cast materials indicate two very different modes. The scanning-electron-micrograph of the bevel joint in Figure 23 shows a very irregular, faceted surface, while the photograph and scanning-electron-micrograph of the butt joint is relatively smooth with some porosity in evidence. These are shown in Figures 24 and 25. The photomicrographs of the cross-sections of the joints help to explain the phenomenon. A very good braze joint is seen in Figure 26 for the bevel joint but the sample has a large grain and traces of porosity. The butt joint is a poor braze with poor wetting and large porosity (Figure 27).

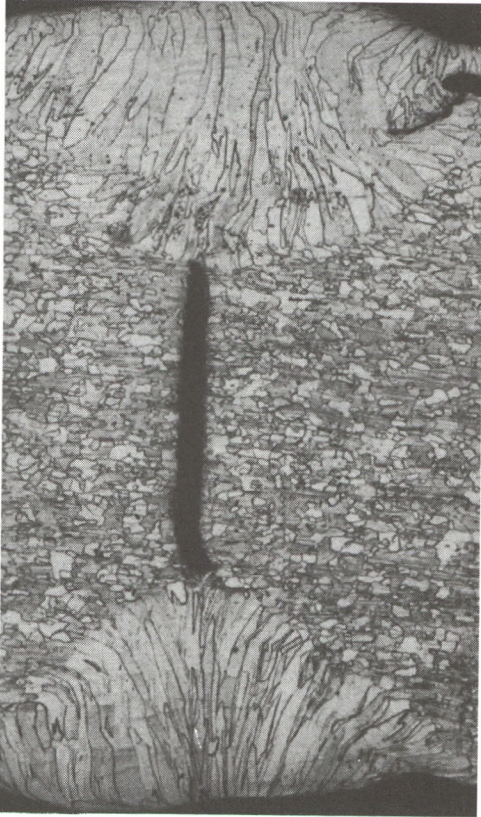
Figure 30

Figure 30. Photomicrograph of the laser-welded bevel joint, cross-section of the 0.075 inch thick, Pt-4.8Ru strip at 50x.

The bend results for the 0.075 inch thick rolled Pt-4.8Ru strip summarized in Table III, is the next data to be examined. Two of the three laser welded bevel joints passed, but the remainder of the joints failed. Photographs and scanning-electron-micrographs of the laser welded butt joints indicate they failed due to lack of penetration. This can be observed in Figures 28 and 29. The photomicrographs of the weld cross-sections confirm the poor penetration with the butt joint and improved penetration with the bevel joint. The inconsistency with the bevel joint would appear to be differing amounts of penetration amongst the three samples. The weld photomicrographs occupy Figures 30 and 31.

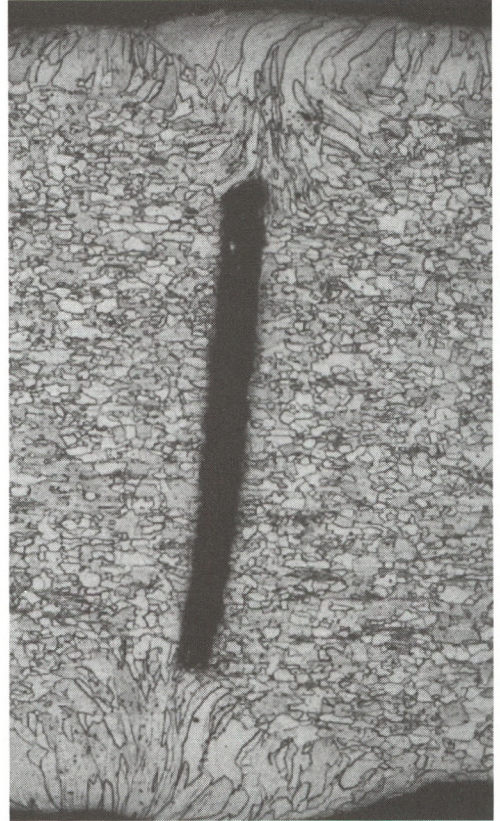
Figure 31

Figure 31. Photomicrograph of the laser-welded butt joint, cross-section of the 0.075 inch thick, Pt-4.8Ru strip at 50x.

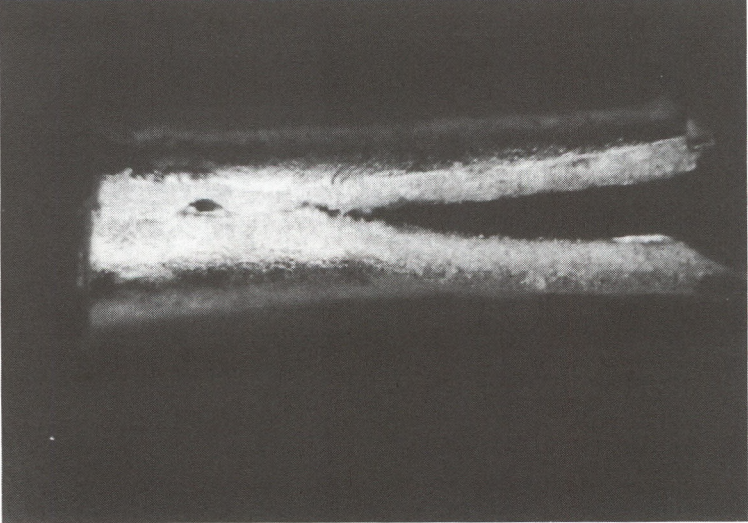
Figure 43. Photograph of the 1T bends of the brazed butt joint of the 0.030 inch thick, 18kt gold strip at 10x.

The fracture behavior of the brazed 18kt gold is more difficult to explain. The photographs of the beveled bend samples are shown in Figures 42 and 43. Examination of the photomicrographs of the brazed cross-sections both etched and as polished, indicate a greater amount of porosity in the bevel joint than the butt joint. The braze of the butt joint appears to be of good quality. However, the butt joint sample shows some grain growth and a band is noted in the unetched sample. Therefore, it is postulated, a heat-affected zone was formed within the butt joint material. The photomicrographs are seen in Figures 44 through 47.
